LIMITED VISUAL WATER INTRUSION SURVEY

**SOARING EAGLE LODGE SNOWSHOE RESORT
SNOWSHOE, WEST VIRGINIA**

PSI PROJECT NO.: 0443-552

MAY 20, 2015

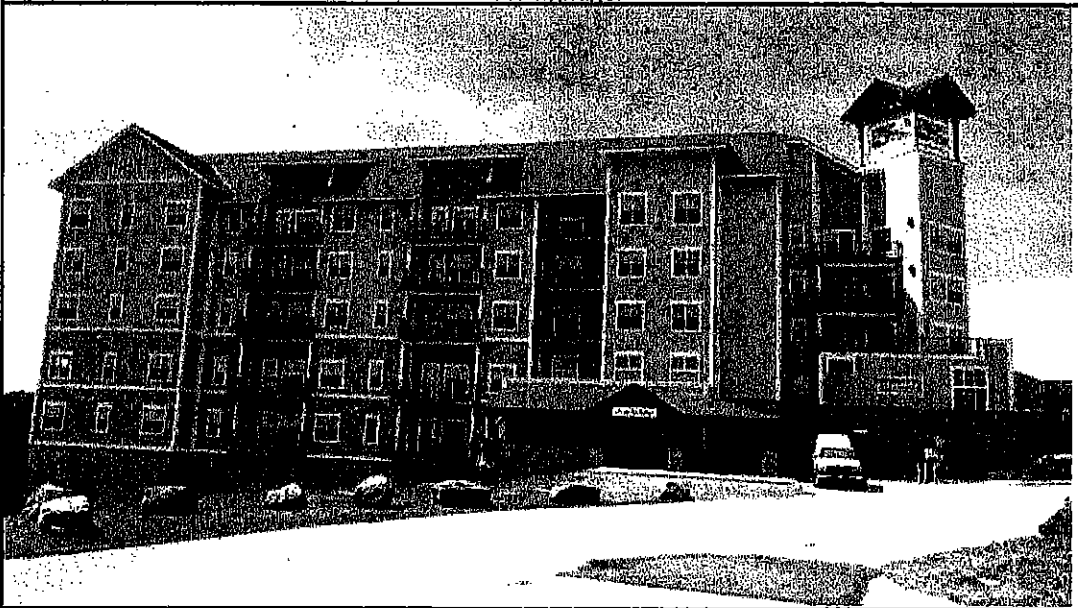
Photo No. 1

Upon arrival it was observed that large sections of shingles were missing in several areas on the roof as well as the lower section of signage on the northwest turret. Once inside the attic space the following roof make-up was observed:

View of the west elevation showing several roof elevations. Note missing shingles and lower signage.

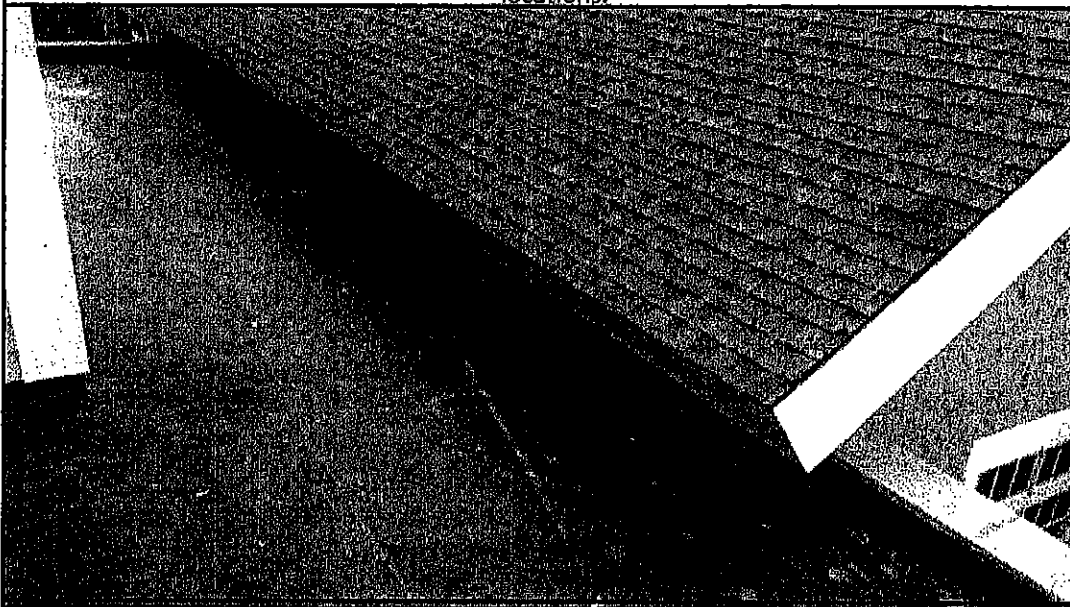
Photo No.11

Overview of corrugated metal roof to wall transition. Fasteners missing in several locations.
